BEACH EVALUATION STUDY
NORTH SCITUATE BEACH
NORTH SCITUATE, MASSACHUSETTS

DEPARTMENT OF THE ARMY
NEW ENGLAND DIVISION, CORPS OF ENGINEERS
WALTHAM, MASSACHUSETTS 02154

OCTOBER 1970

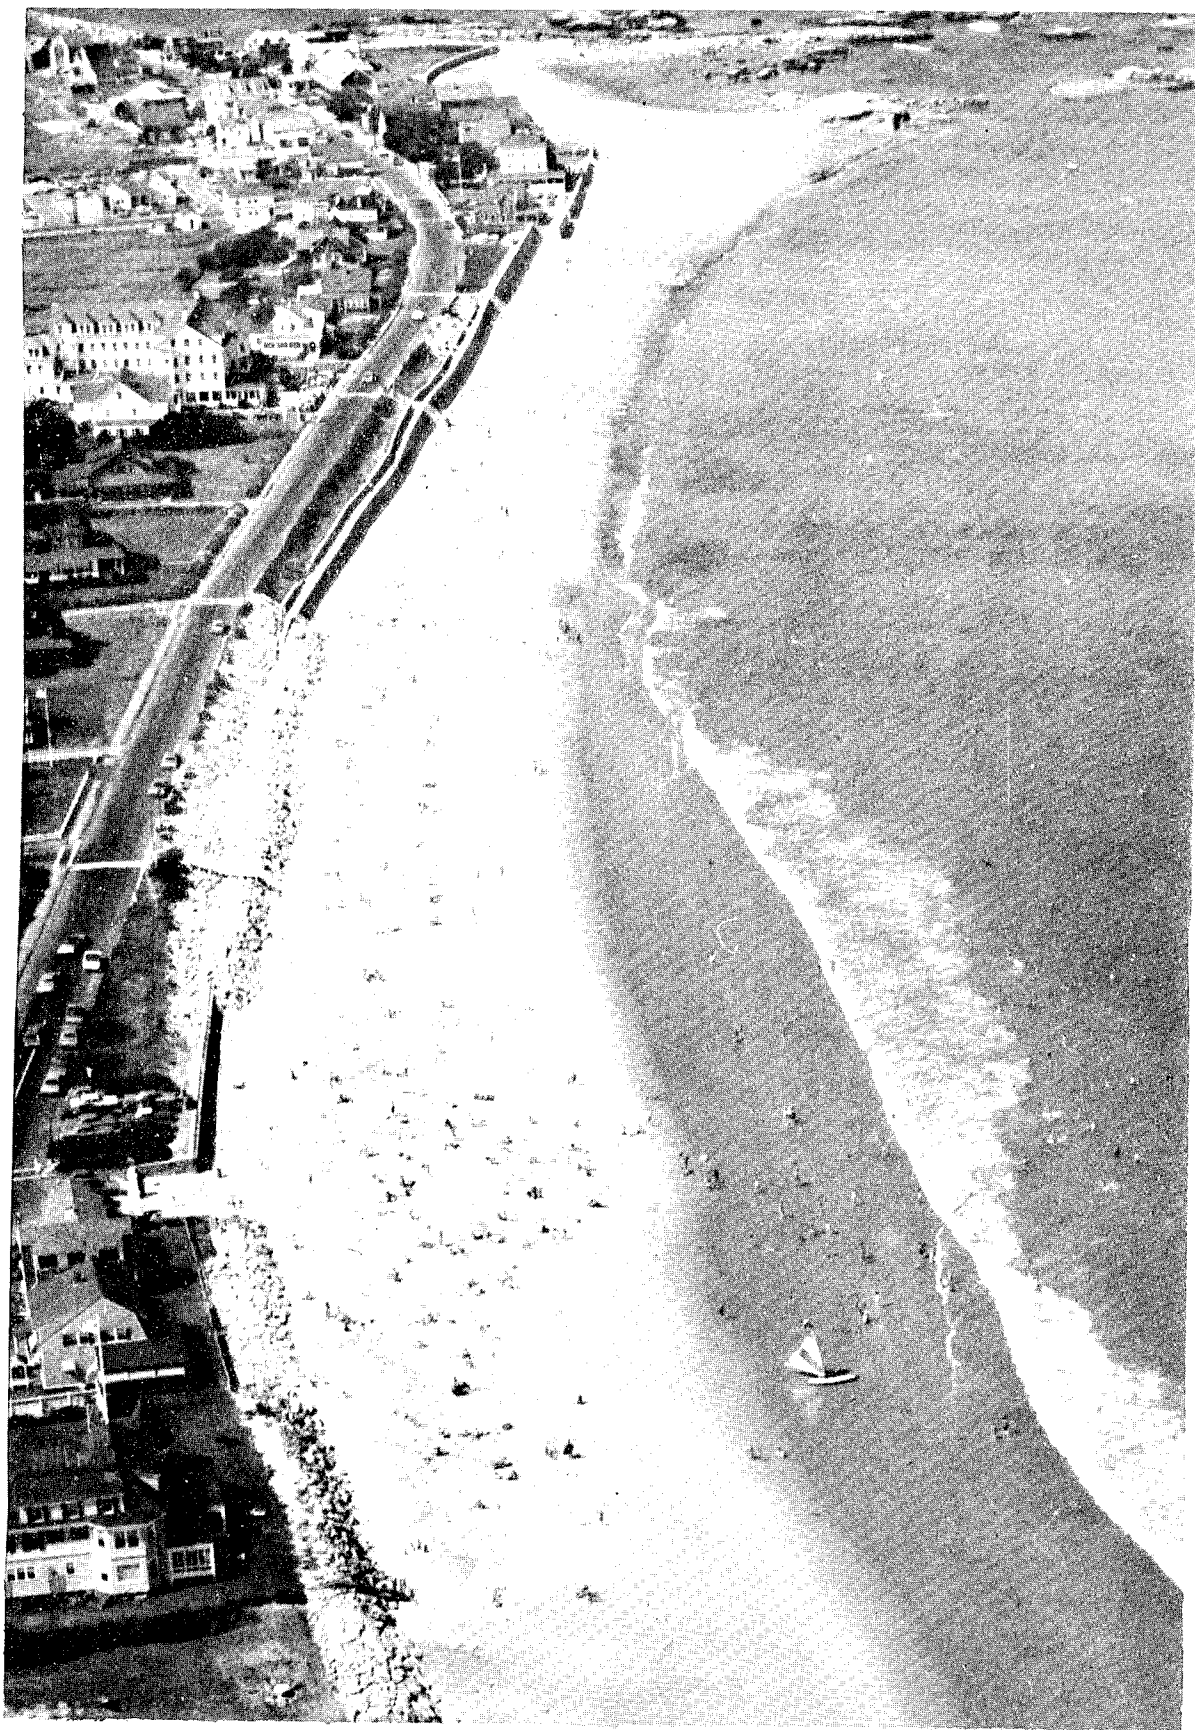
PHOTO 1. NORTH SCITUATE BEACH, JULY 1967. Near high tide looking north along newly constructed beach.

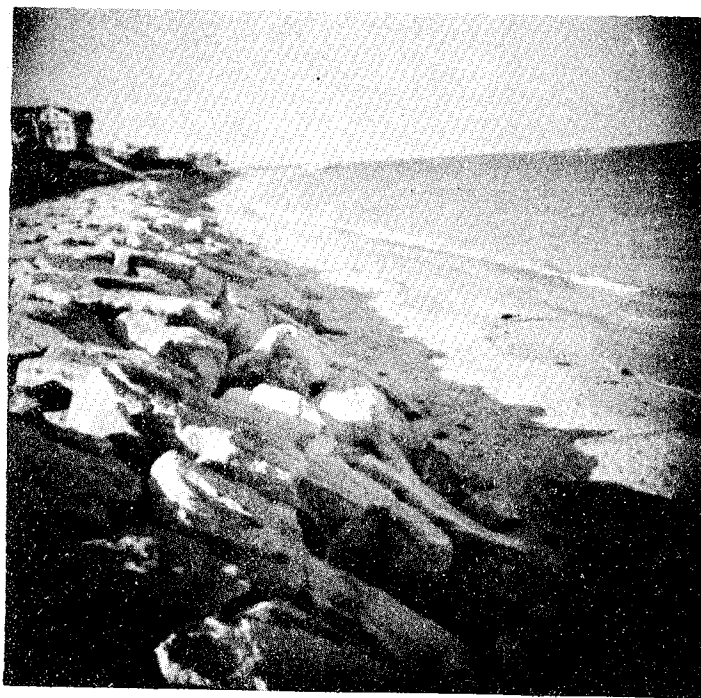
PHOTO 2., 6 OCTOBER 1970. Looking north along reveted section of beach. Note narrowness of beach berm at near high tide.

4. The problem results from storms occurring during higher than normal tide levels. Storm-driven waves attack and overtop the beach. The storms are frequent. Erosion of the backshore allows larger waves to runup and overtop the beach, thus reaching the seawalls. The massive concrete walls backing most of the beach, then aggravate the problem by reflecting the waves back on the beach. Where seawalls are fronted by rock revetment, the reflection forces are reduced which apparently has helped maintain a wider berm than at unrevetted sections.

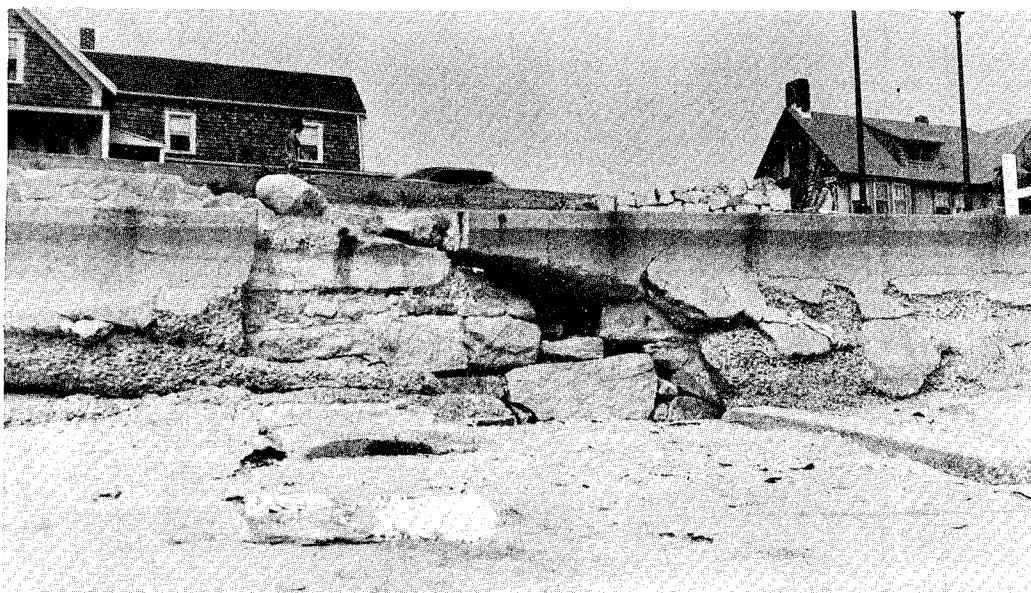
PHOTO 4., AUGUST, 1969. Storm-driven waves have damaged sections of a concrete faced stone wall along a sector of backshore extending northerly of similar wall protected by revetment.

11. Considered Project Modifications. Consideration has been given to modification of the project in the light of better technical knowledge of wave induced processes and annual losses ascertained since completion of the cooperative study. Any offshore breakwater type construction to substantially reduce storm-driven waves is much more expensive than alongshore revetment or groin structures and therefore, cannot be economically justified. This type of construction also requires the addition of artificial fill required for recreational beach use in this area where massive alongshore improvements has reduced the natural beach building material to a minimum. The plans include raising and widening the beach, with and without groins, providing a beach with a 50-foot wide berm at elevation 17.0 feet mean low water (at about the elevation of maximum wave runup), with a seaward slope of 1 vertical on 15 horizontal to mean high water, thence 1 vertical on 20 horizontal. Also included is consideration of providing stone revetment along about 800 feet of seriously damaged wall, as a northerly continuation of existing revetment rather than the beach fill.

17. It is also concluded, however, that in view of the great need for recreational use beaches in Massachusetts, particularly within the Boston megalopolis, that an economically feasible project could be developed by provision of a higher and wider beach berm for needed stability (largely in a reduction of losses from reflection from the seawalls). It would require expansion of existing sanitary and parking facilities to accommodate the additional recreational populace estimated in project justification with high periodic nourishment requirements. This would require that the Commonwealth of Massachusetts and the town of Scituate participate in a more costly project including the cost of further expansion of facilities. In lieu of a project with Federal participation, local interests can protect the seriously damaged section of concrete walls by extension of the existing stone revetment about 800 feet north along the damaged section.

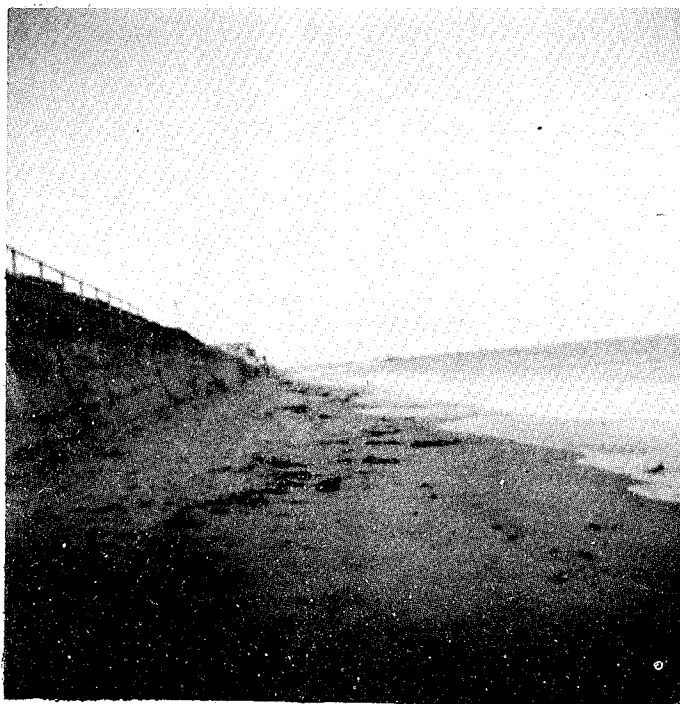
3. The Problem. The problem involves the rapid loss of beachfill that has been experienced during the two years since construction of the project at which time the Commonwealth placed 160,000 cubic yards of fill on the beach, (about 80 cubic yards per foot of beach). The beach has greatly diminished in width along most of the length with a general lowering of the beach berm. This is particularly true along the northern half of the beach, where the loss of sand now exposes the concrete apron structure fronting the seawalls.

PHOTO 7., OCTOBER 1970. Looking north along narrow northern half of beach at near high tide. Note narrowness of beach compared to PHOTO 5.
